Portage Creek Sediment Remediation Project Kalamazoo, Michigan

Pre-Sediment Removal Structure Feature Assessment Removal Area SA6

F&V Project Number: 809930
April, 2012

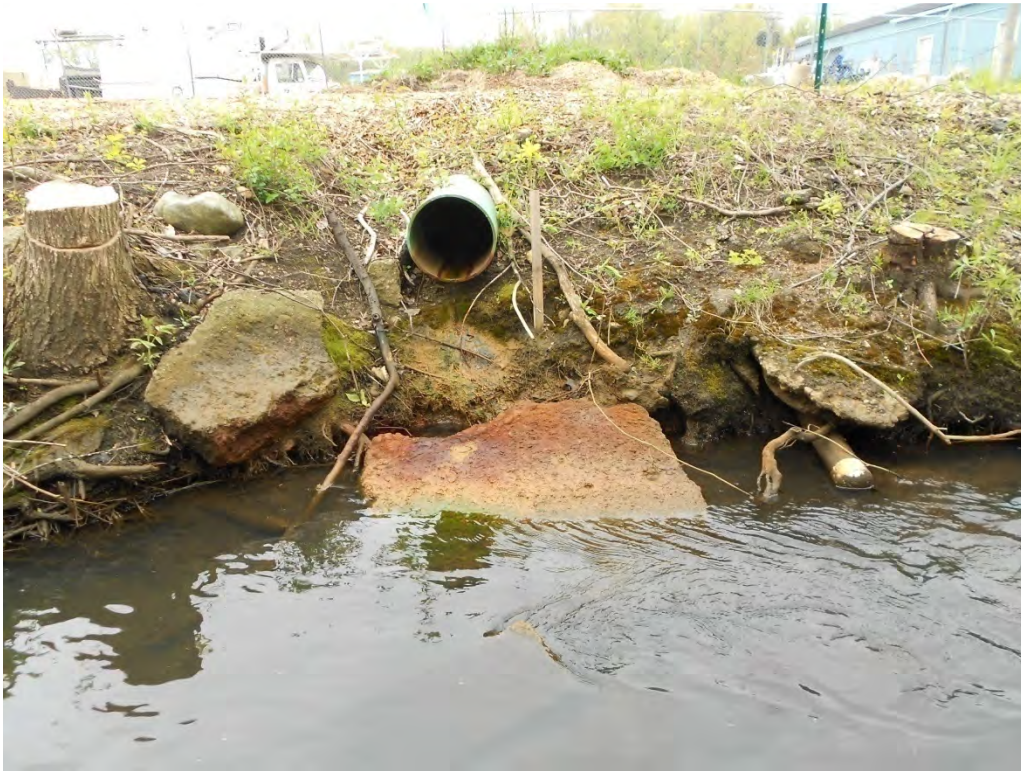
- The 12-inch sewer is undermined approximately 12 inches, with 2-3 feet of bank erosion around the pipe.
- There is a 12 inch gap between the pipe and the splash block below. The invert is approximately 2 feet above the waterline.
- The smaller capped pipe extends approximately 2 feet into the channel.

View of the outlet from the channel area

- We understand that the lift station outlet is to be plumbed to discharge beyond the cofferdam limits to facilitate dewatering.
- The splash block should be removed and replaced in kind to facilitate sediment removal.
- The 3½" pipe should be cut back toward the bank and re-capped as required to facilitate sediment removal.

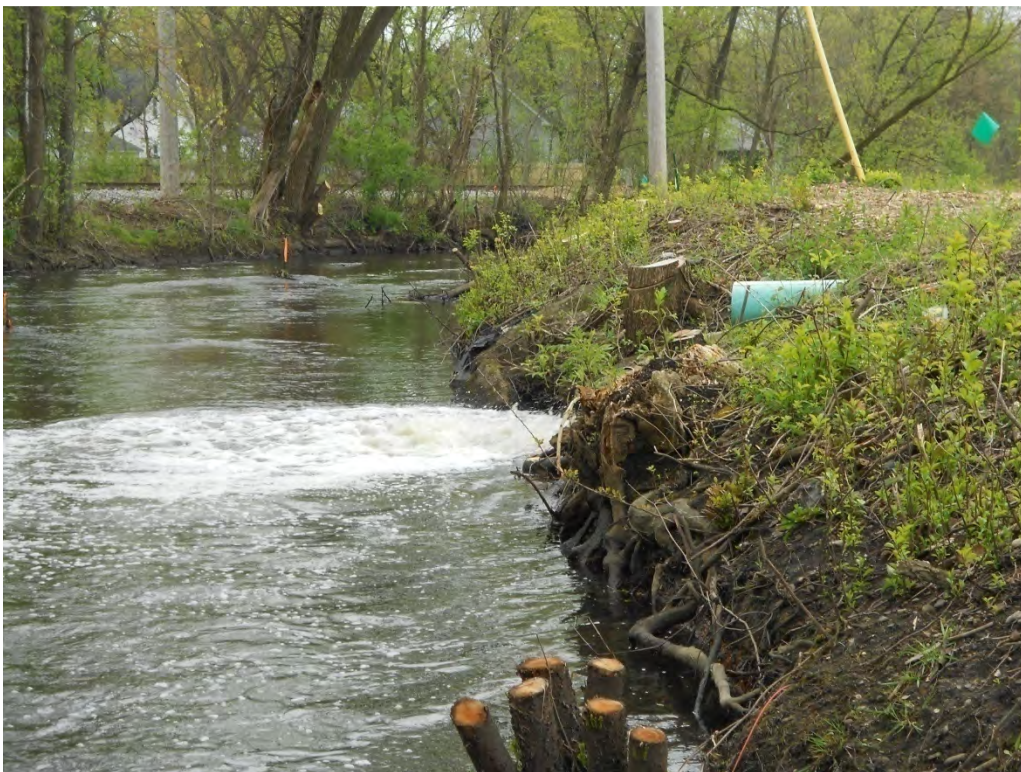
View of the outlet during discharge

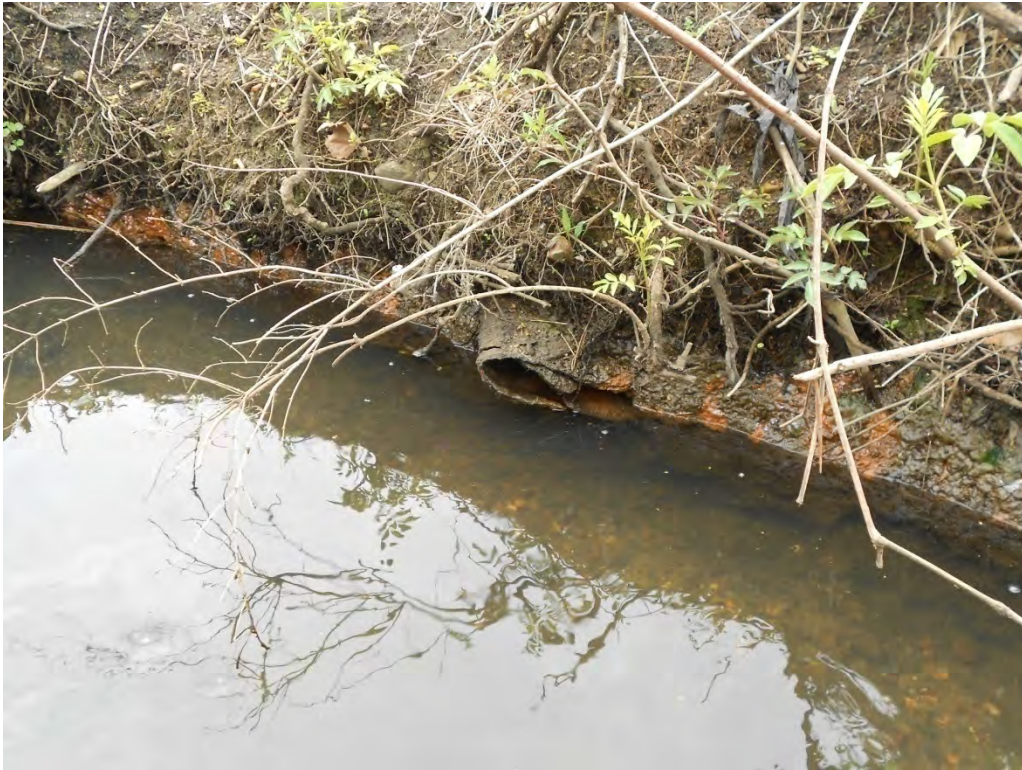
- The pipe is severely corroded and has been crushed. It appears to be abandoned.

View of the outlet from the channel area

- It is recommended that the City of Kalamazoo be contacted to confirm that the outlet can be removed in conjunction with sediment removal.

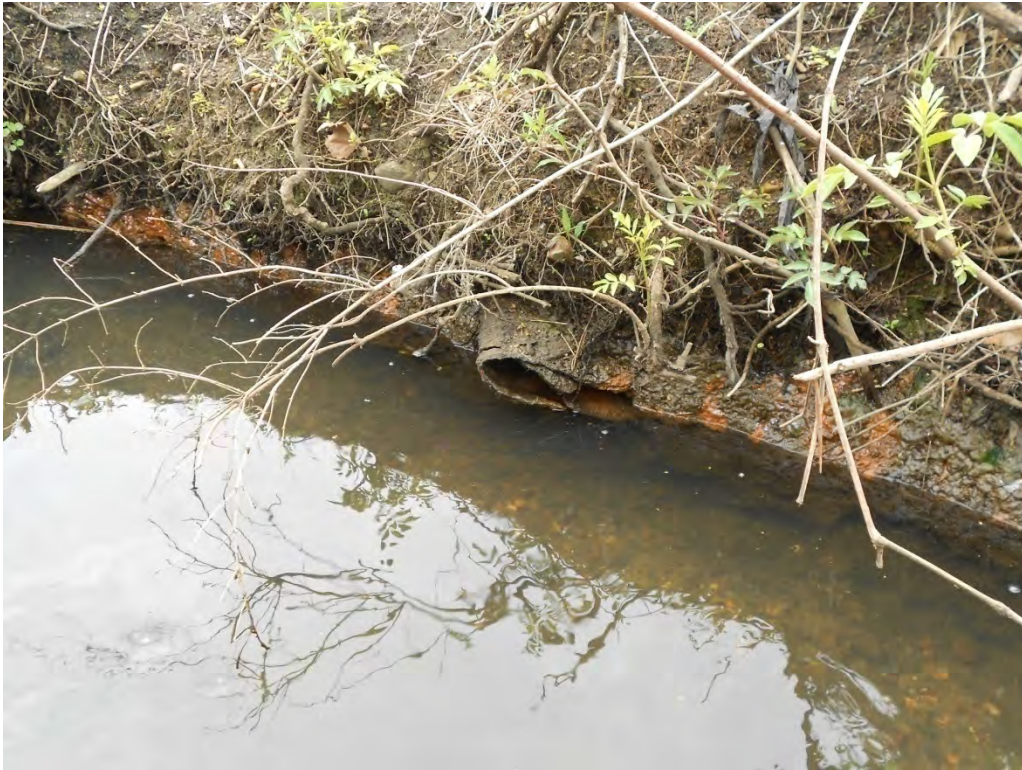
- The pipe is severely corroded and has been crushed. It appears to be abandoned.

View of the outlet from the channel area

- It is recommended that the City of Kalamazoo be contacted to confirm that the outlet can be removed in conjunction with sediment removal.

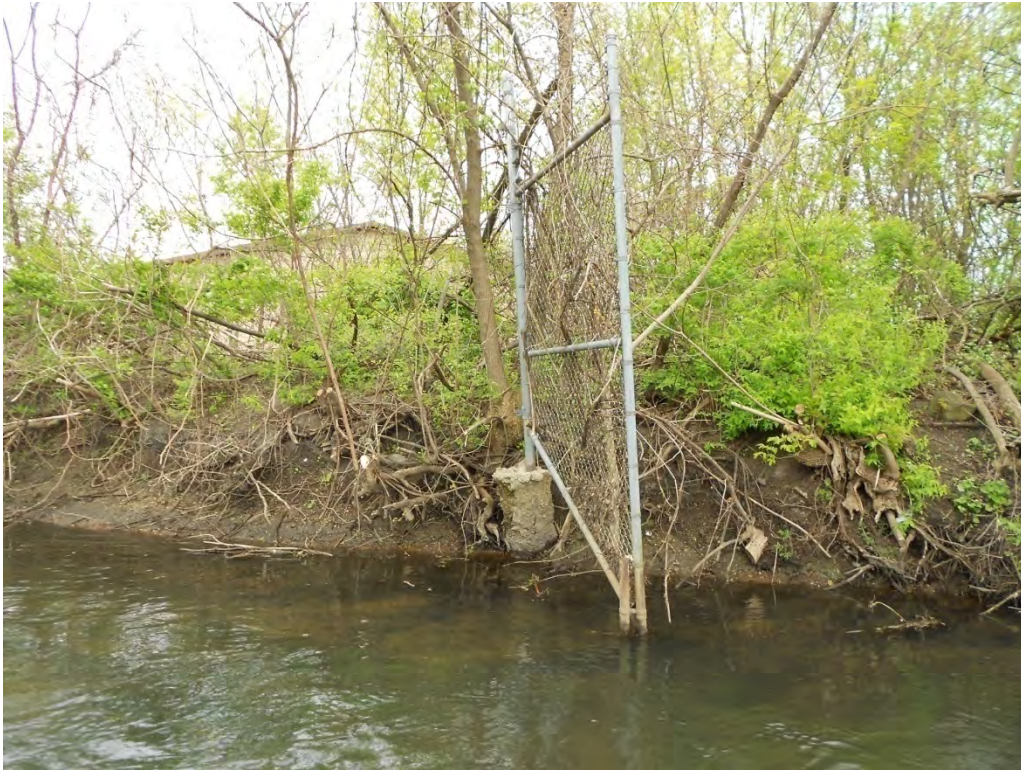
- The concrete base at the bank is nearly completely exposed from bank erosion.
- There is moderate debris on the upstream face of the fence.

View of the fence from the channel area

- From the technical memorandum, we understand this fence is to be removed prior to sediment removal operations and replaced in kind.

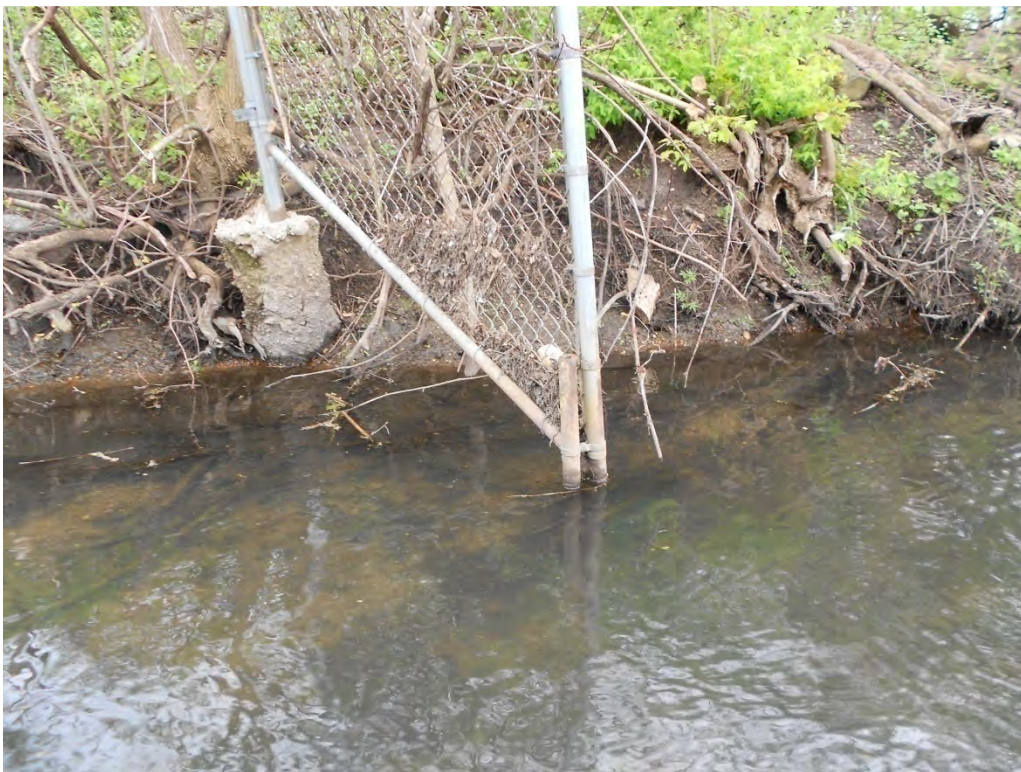
View of the concrete base at the bank and support post in the channel

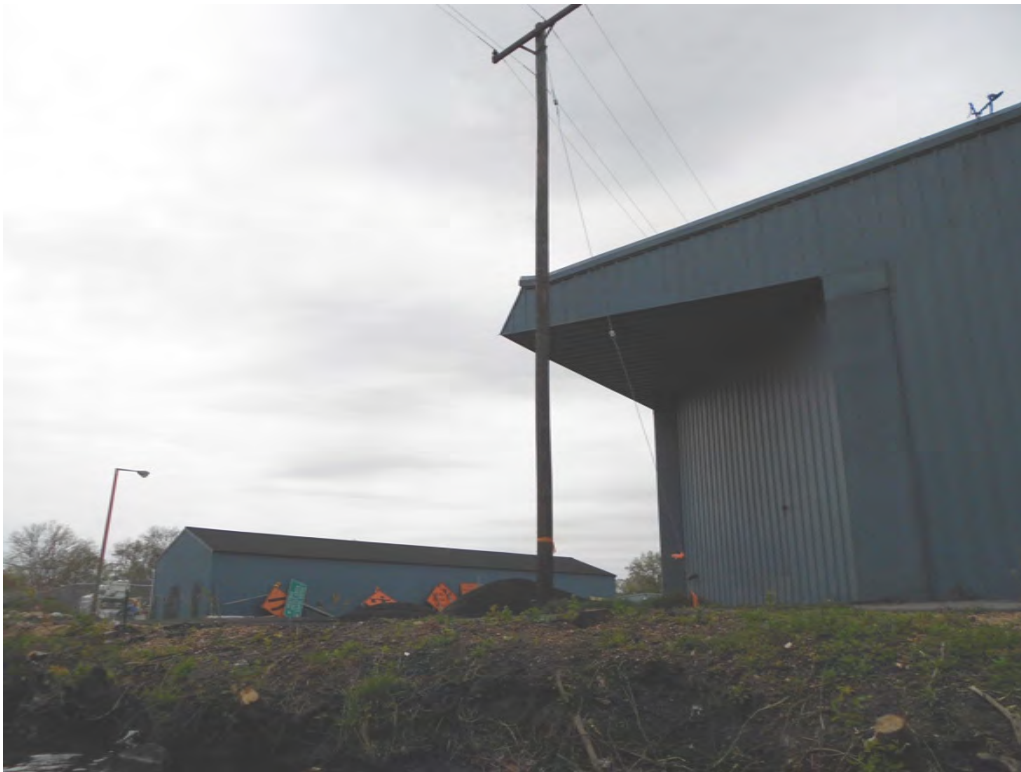
- The utility pole appears to be in fair condition.
- The guy wire is noticeably slack and not supporting the pole.
- The asphalt surface between the pole and the channel is severely deteriorated.

View of the pole and guy from the downstream channel

- The pole and guy should be protected from damage during excavation operations by installing construction fencing around them or other means to make operators and drivers aware of their location.
- Excavation should be avoided within a 1:1 projection of the surface at the pole and guy to avoid compromising their support. Based on their location relative to the channel, it does not appear that this will restrict sediment removal in the area.

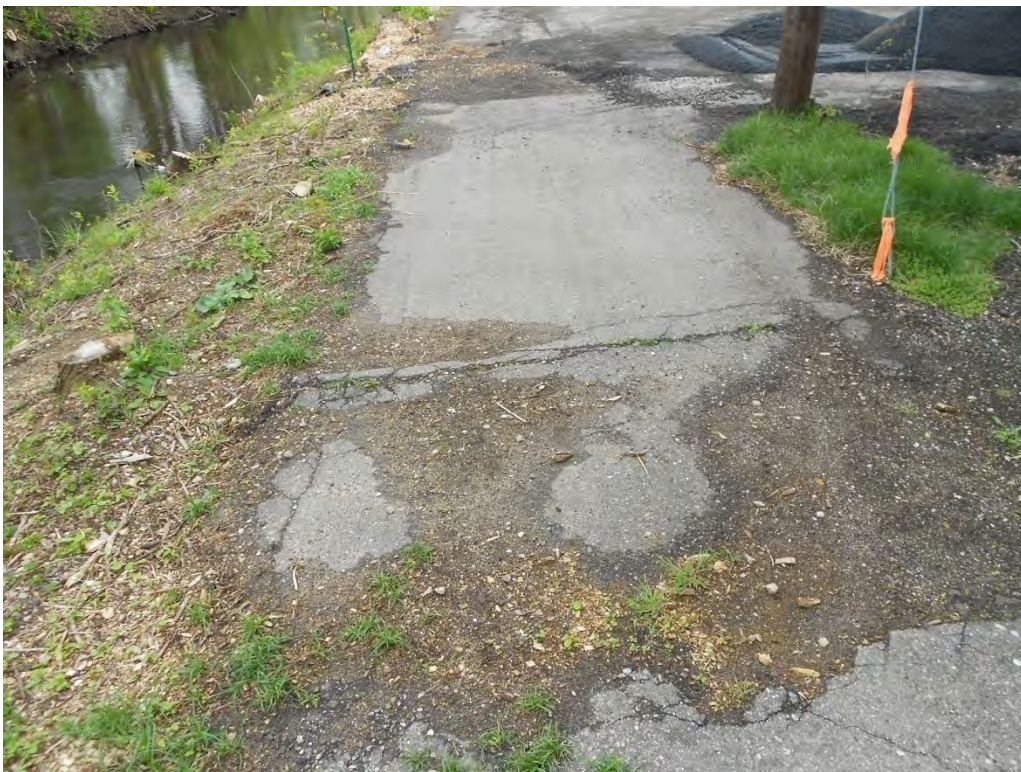
Condition of the asphalt surface between the pole and channel

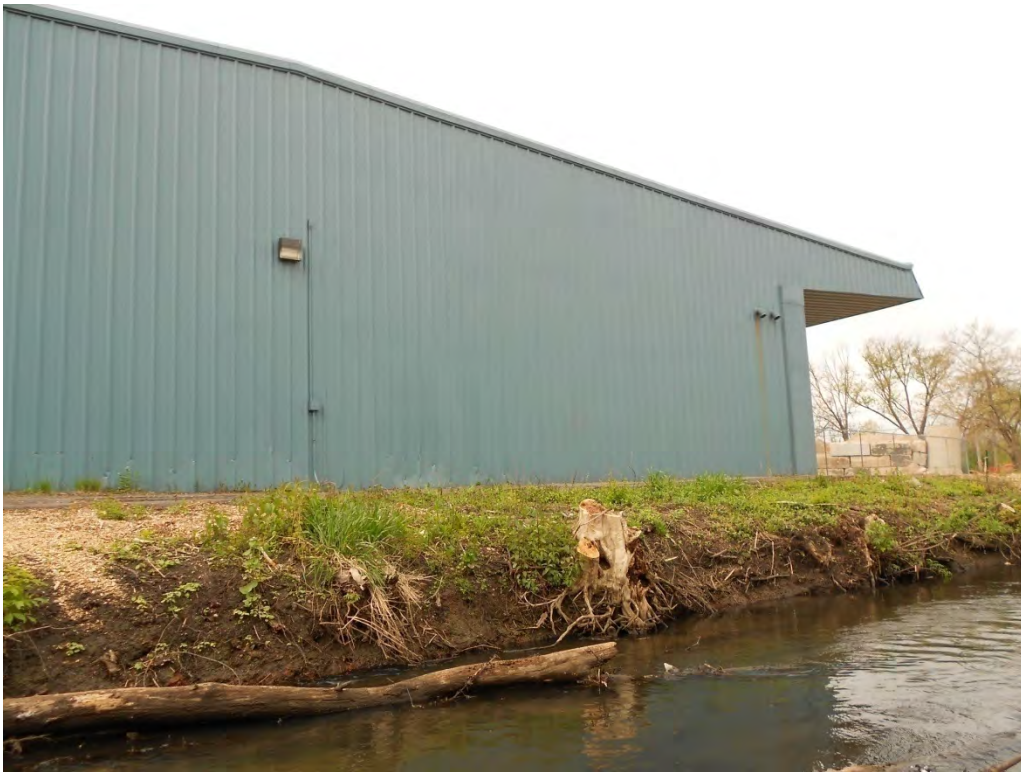
- The building appears to be in fair condition.
- The asphalt access road is severely deteriorated with cracking and potholes throughout and large areas of missing pavement.

North end of the building viewed from the channel

- The building should be protected from damage during excavation operations by proper operational planning and construction staging.
- It appears that the building is a sufficient distance from the excavation area that sediment removal will not impact its foundation.

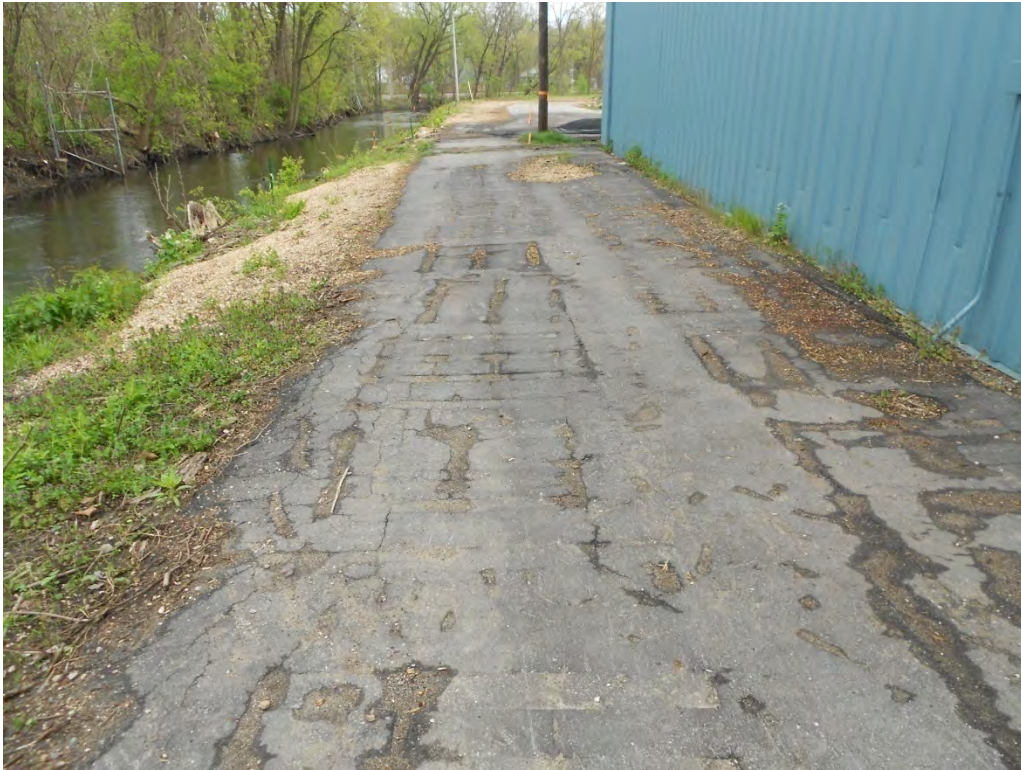
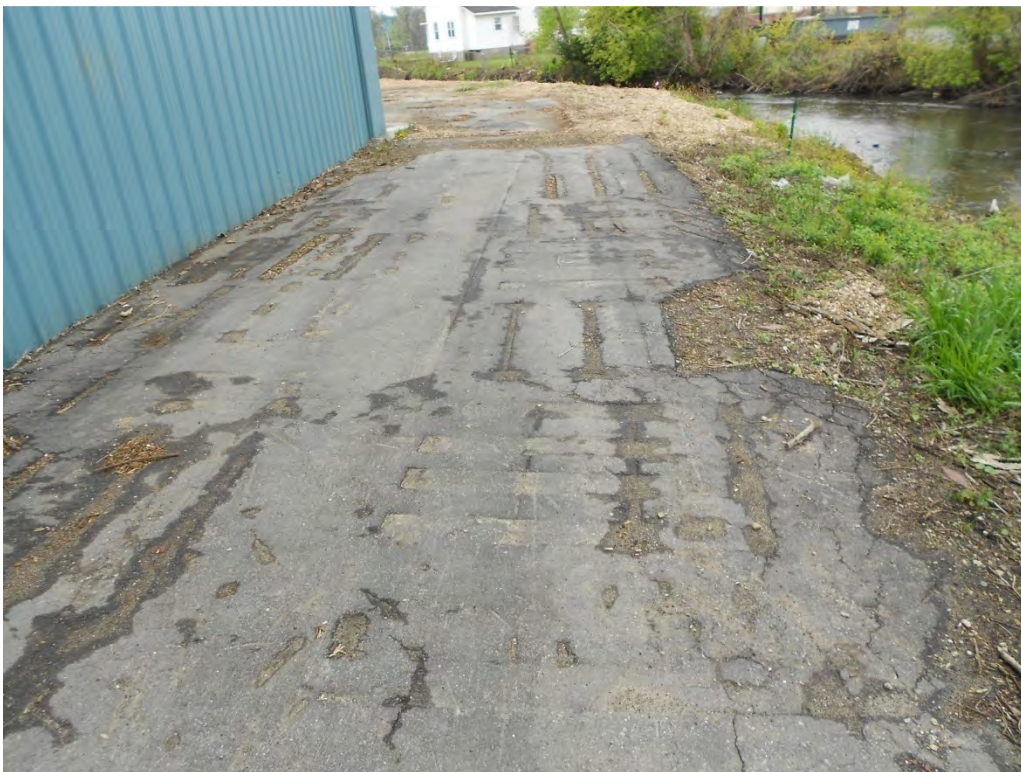
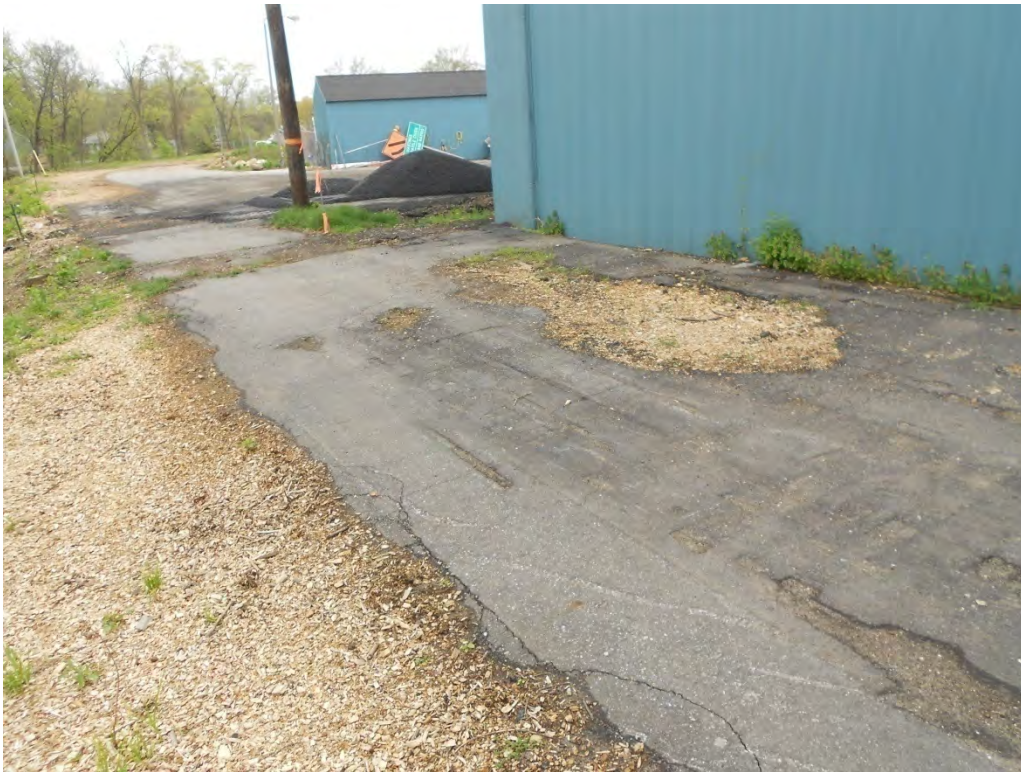
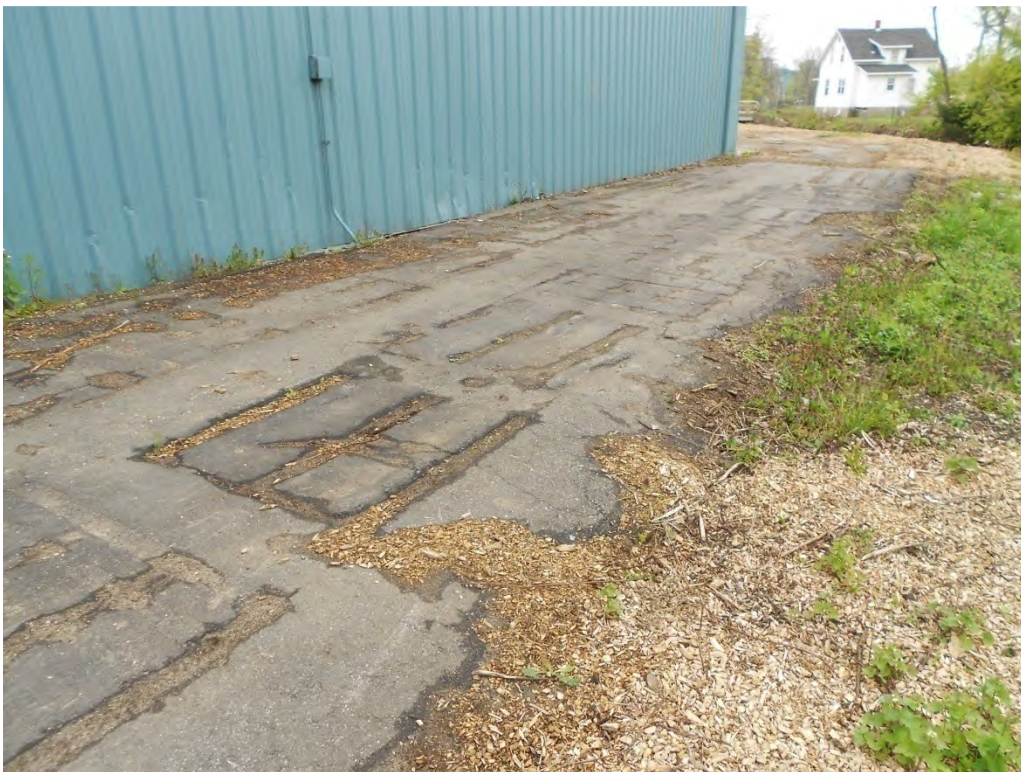
Severe deterioration of the asphalt access road

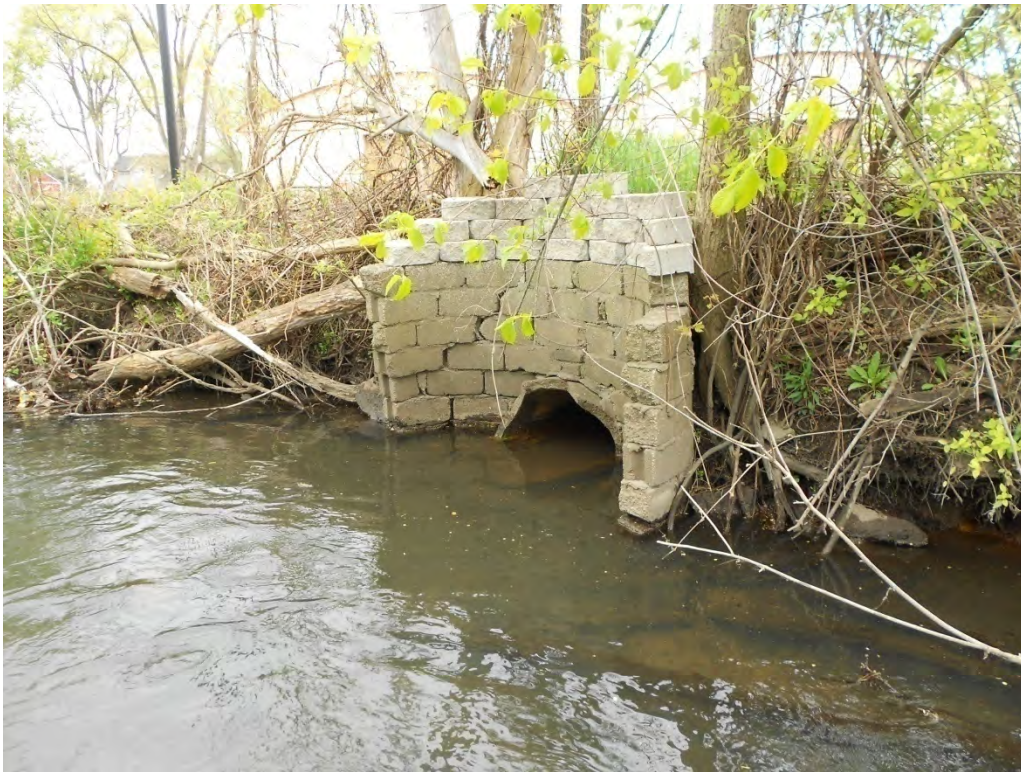
- The headwall has severe step cracking. It is leaning toward the channel. The north side is worst, leaning severely at approximately 20 degrees.
- The channel is approximately 2-3 inches below the invert of the outlet, however, no undermining was detected.
- There is significant tree growth behind the headwall, which is contributing to its outward lean.
- There is a ½" gap between the pipe and the headwall mortar.
- The bank is eroded and undermined approximately 12-18" in the area of the structure.
- The last section of pipe appears to have been broken back as the channel bank eroded.

Overall view of the structure from the upstream channel

- The outlet should be isolated with a cofferdam to allow for dewatering during excavation. It is recommended that the cofferdam be located a minimum of 4 feet from the structure. Because of the severe bank erosion in the area, the headwall is no longer functioning as intended. Therefore it is recommended that the City of Kalamazoo be contacted to confirm that it can be removed in conjunction with sediment removal or cofferdam installation.

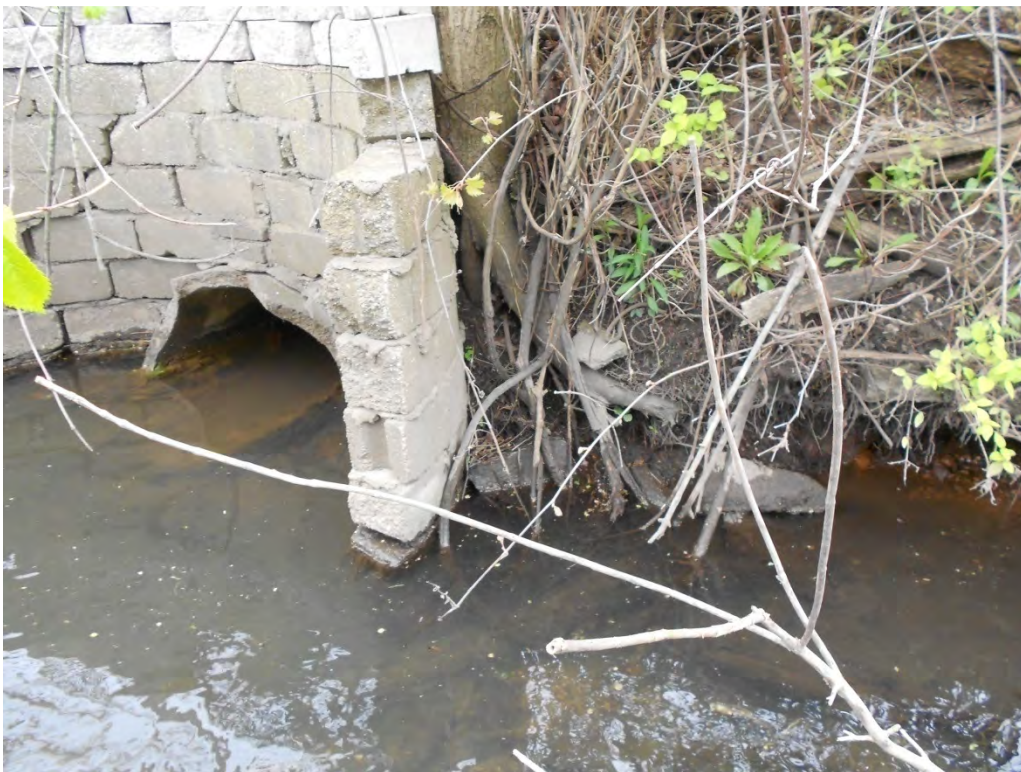
Bank erosion and root growth around the headwall

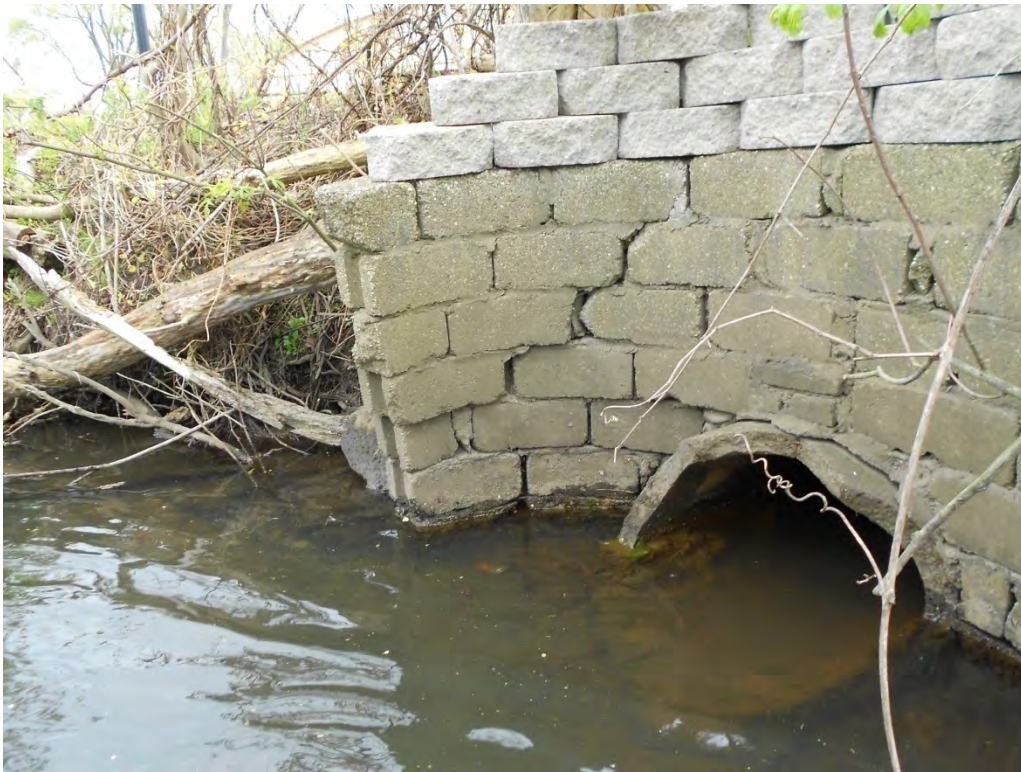
Severe cracking and leaning of north side of headwall

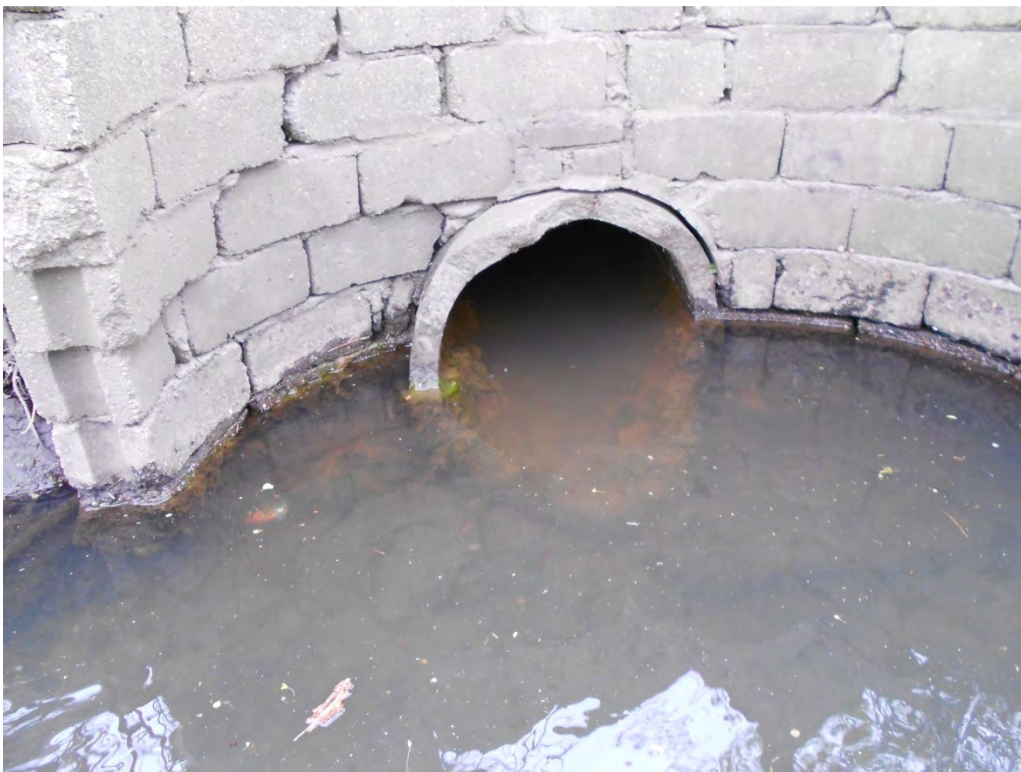
Gap between concrete pipe and headwall mortar

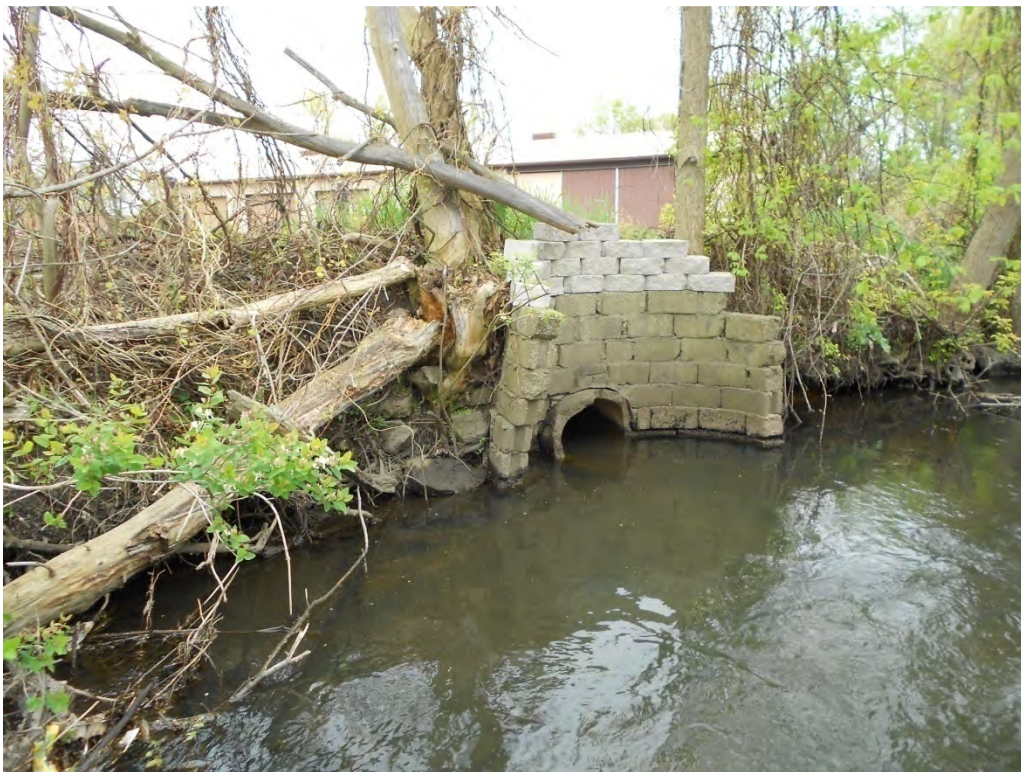
Overall view of structure from downstream channel

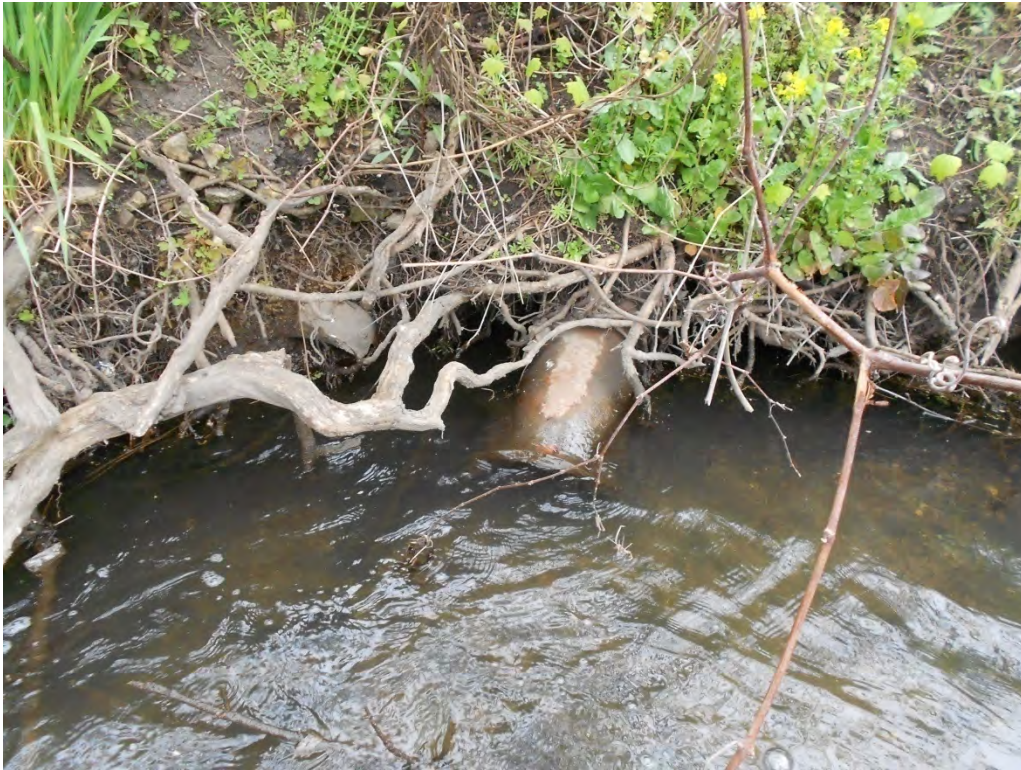
- The end section of the pipe has failed and is deflected downward into the channel.
- The channel bank is severely eroded and undermined in the area of the pipe.

View of the structure from the channel

- The end section of pipe should be removed and replaced to with corrected alignment or cut off at the bank to accommodate sediment removal.

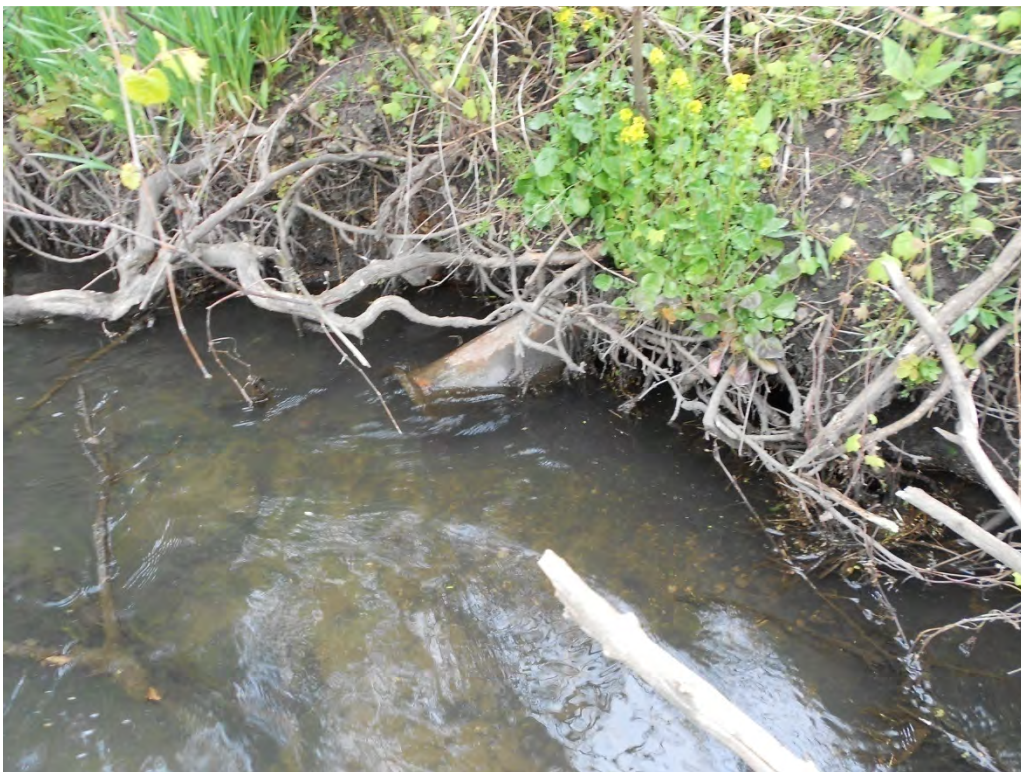
End section deflected and supported on the channel bottom

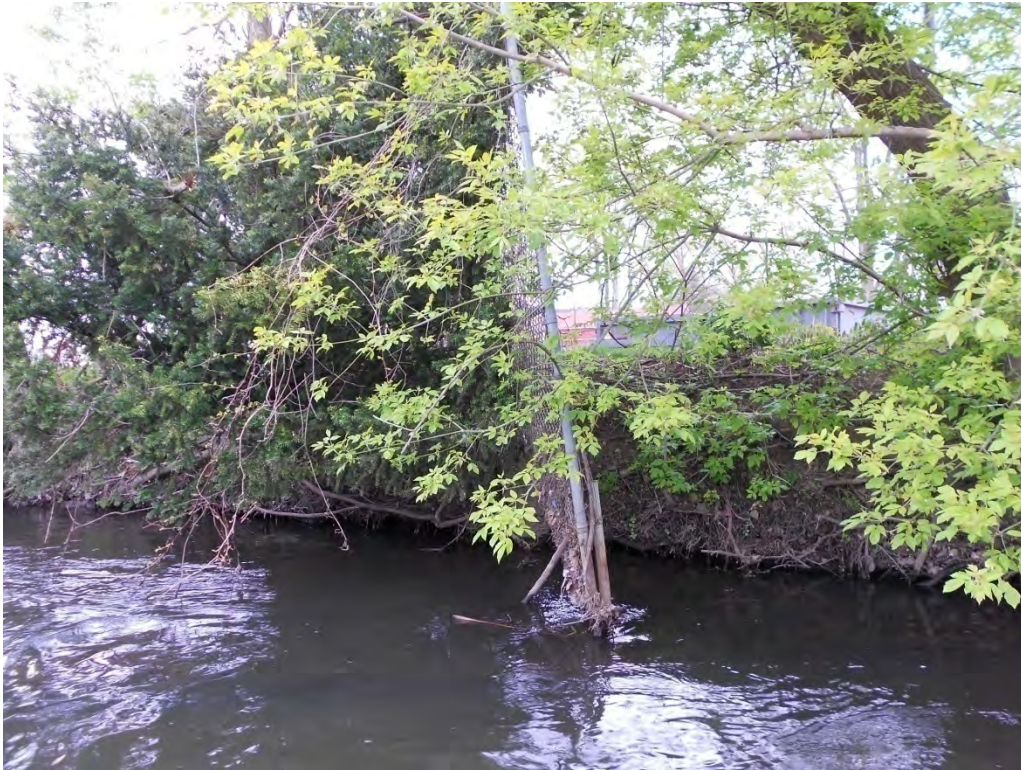
View of the fence from the channel

- From the technical memorandum, we understand this fence is to be removed prior to sediment removal operations and replaced in kind.

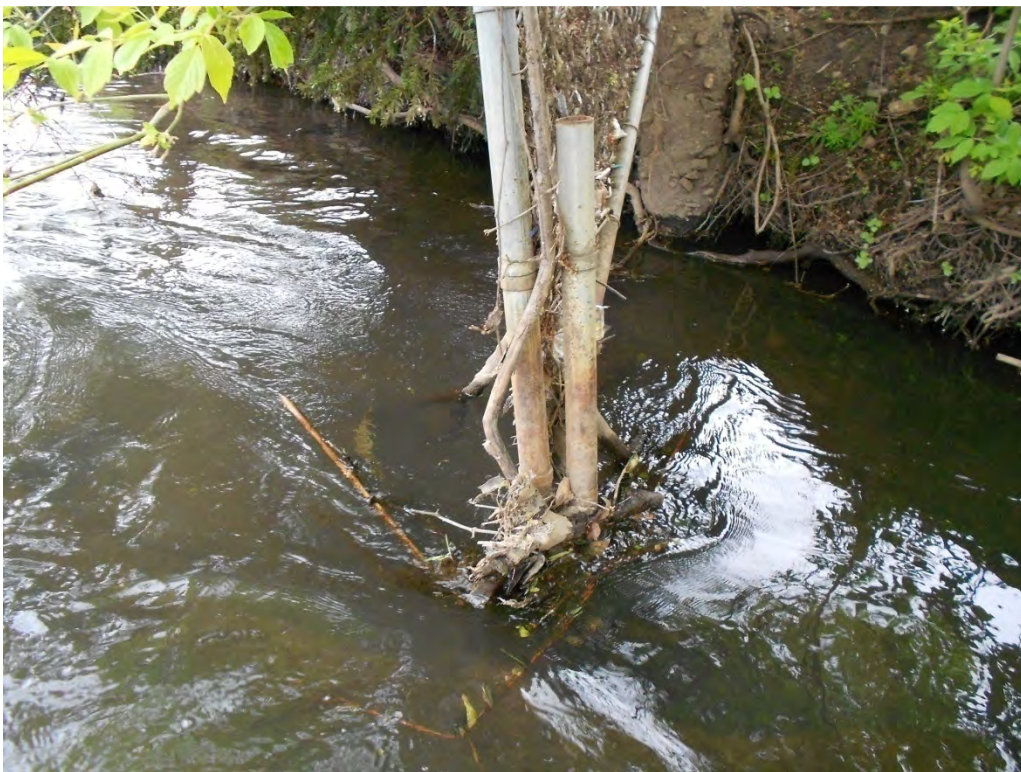
Steel support post in the channel

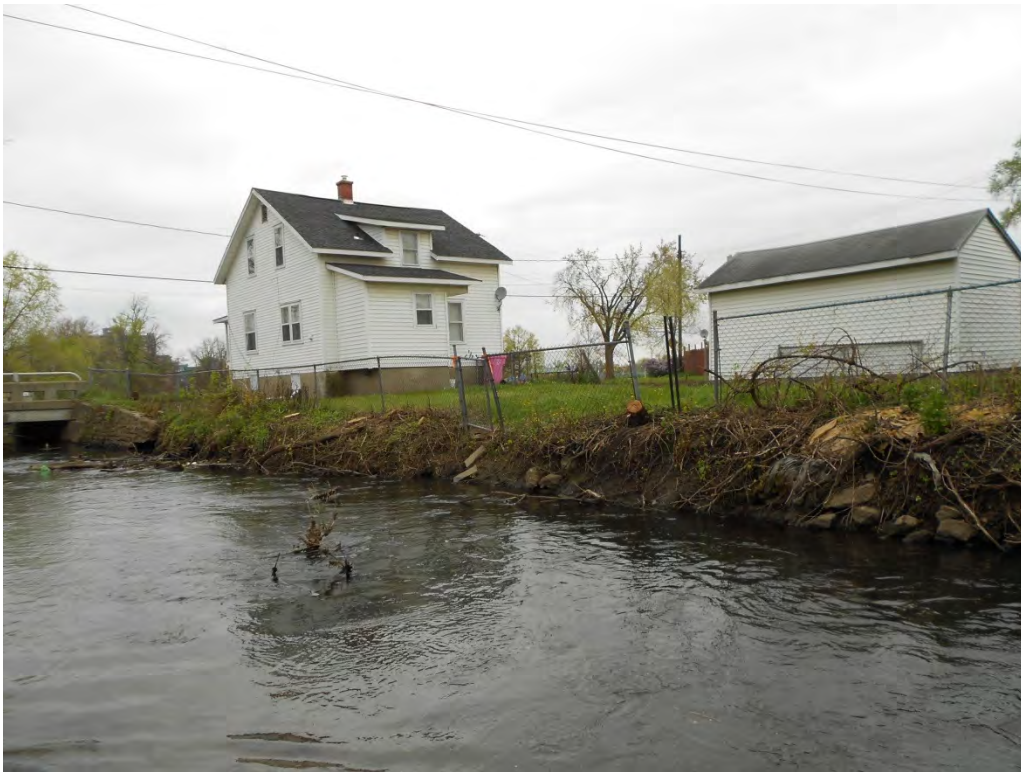
View of the structure from the upstream channel

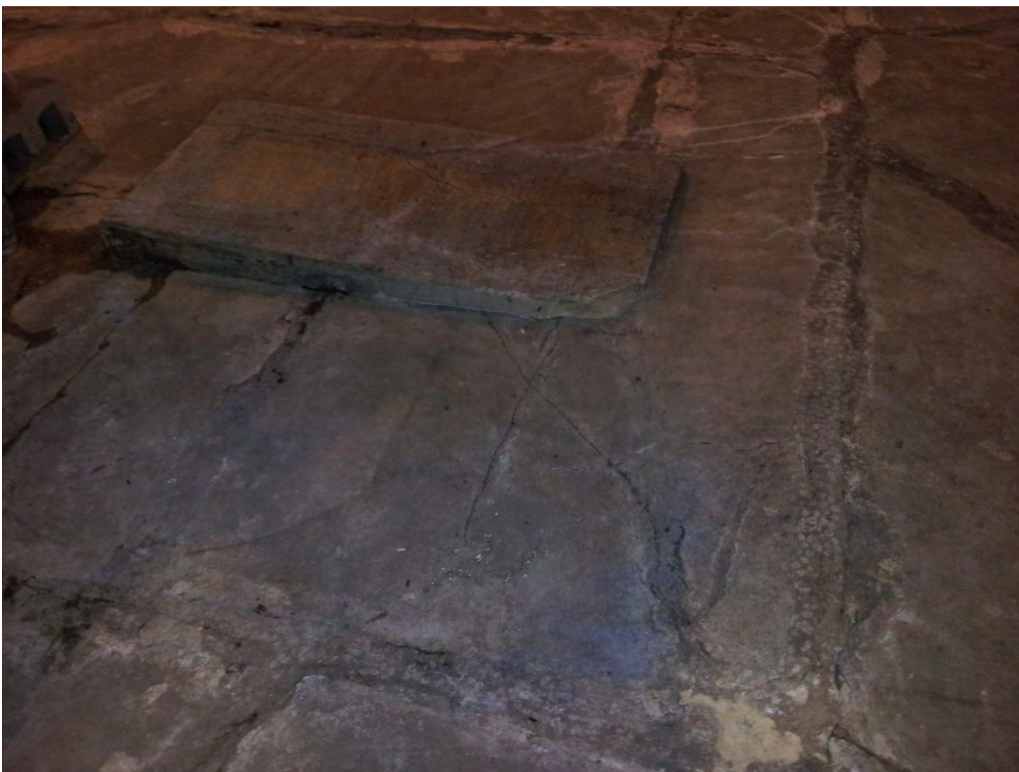
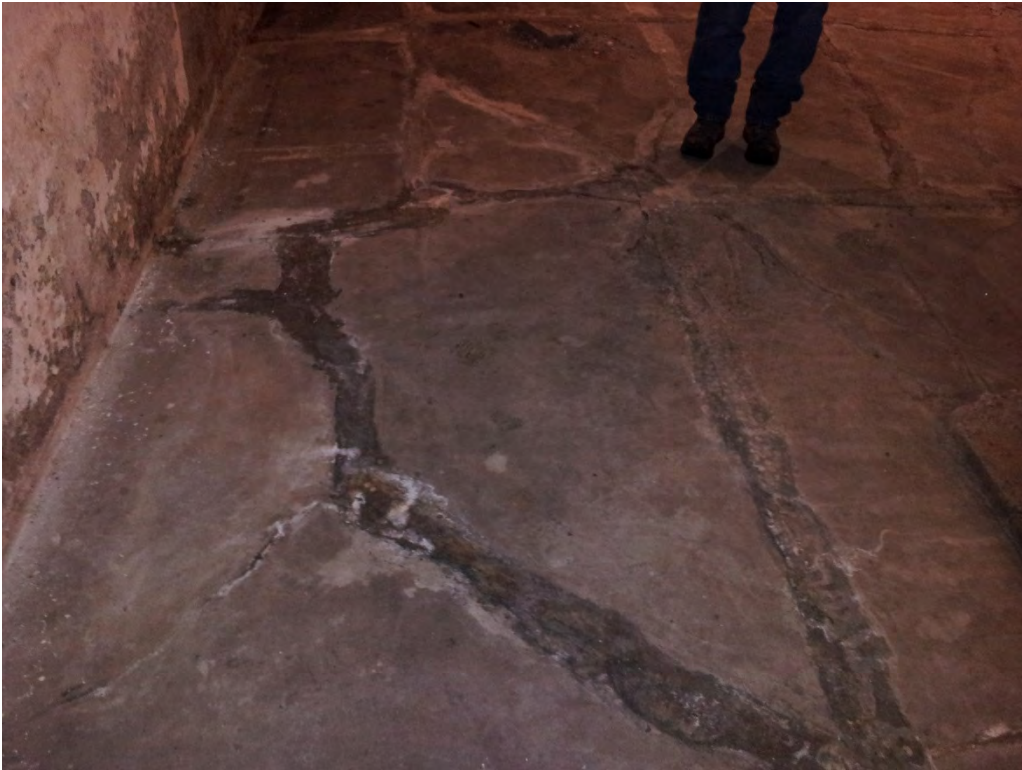
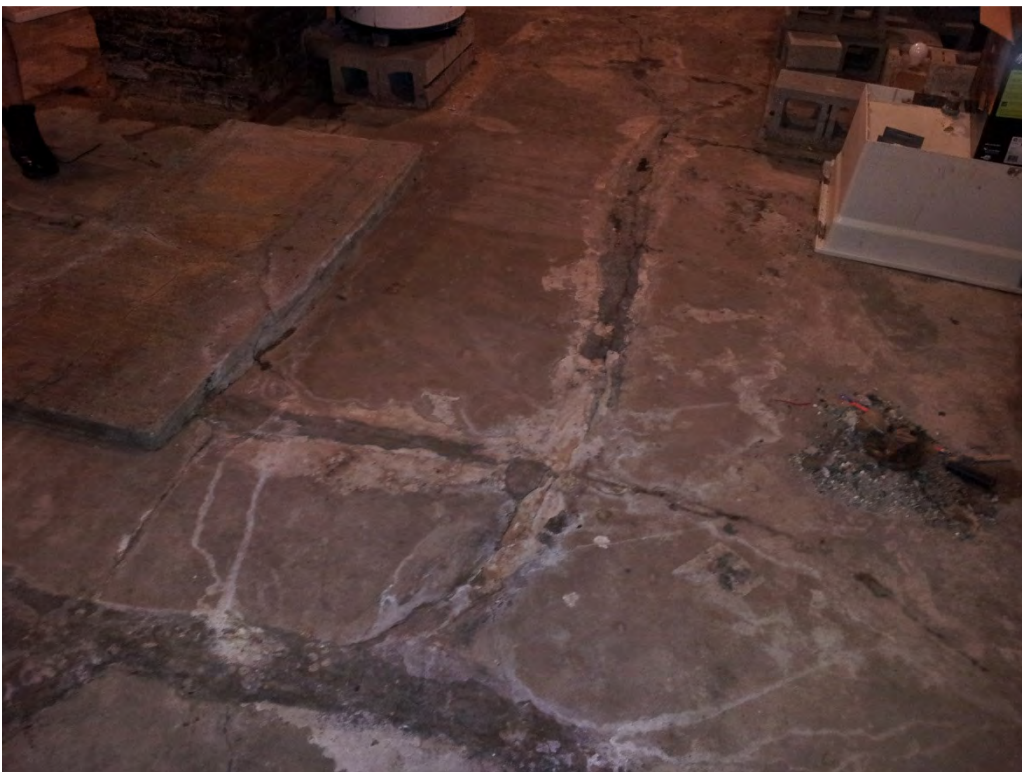
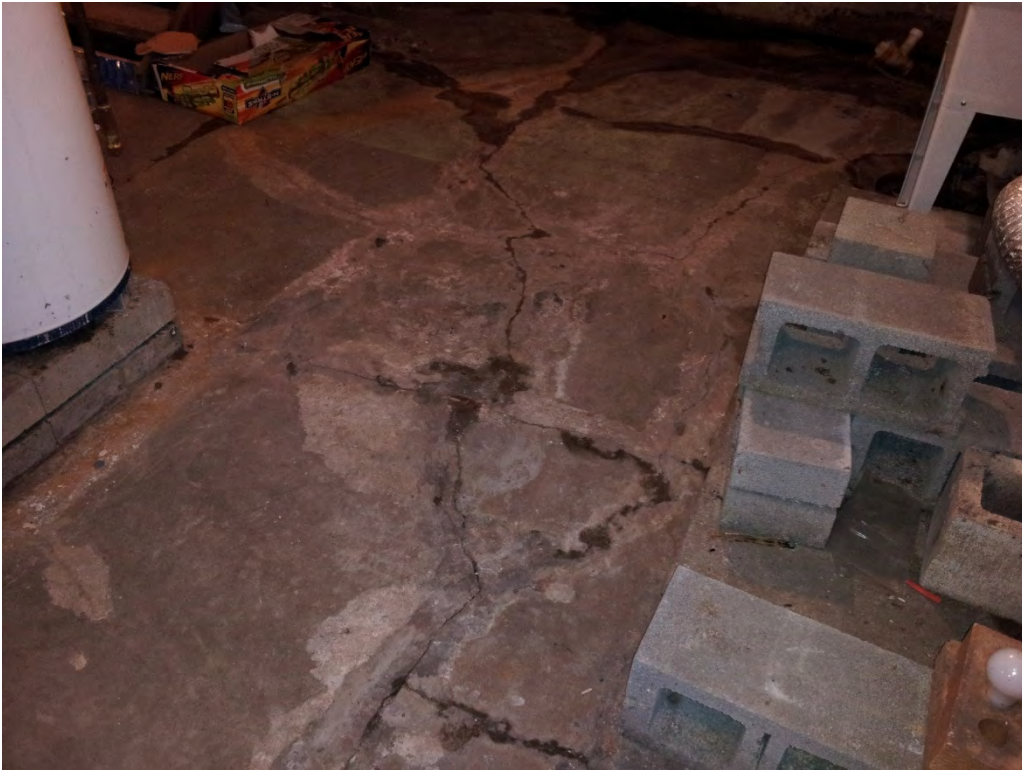
- The fence is leaning severely in the area of the gate and has a missing section just south of the gate.
- The bank along the property has been cleared. It is very steep, near vertical in places, and undercut approximately 12 inches with exposed roots throughout.
- The current resident indicated that the basement area routinely floods with about 4 feet of standing water. The elevation of the basement floor slab appears to be at or near the normal water surface of the creek. The sump pump crock had standing water just below the floor slab at the time of the review.
- The concrete floor slab in the basement has severe cracking and heaving throughout, with prior grout seal and re-cracking. The west foundation wall has vertical, horizontal and diagonal cracking with grout seal and re-cracking. Cracking in the wall appears to concentrate around the window penetrations.

Severe cracking and heaving of concrete slab in basement

- We understand that the fencing will be removed by the current resident. It should be replaced in kind after sediment removal operations at the discretion of the property owner.
- The foundation of the home appears to be of sufficient depth and distance from the excavation area that it will not require special protection. However, because the foundation is severely deteriorated, vibration from cofferdam installation could impact the structure. Therefore, it may be advisable to monitor vibration near the structure to supplement this report should a claim arise.
